# Conair Cord-Keeper 169XR Cool Down Button Replacement

This guide will help you replace the cool down button and possible the spring that sits behind it.

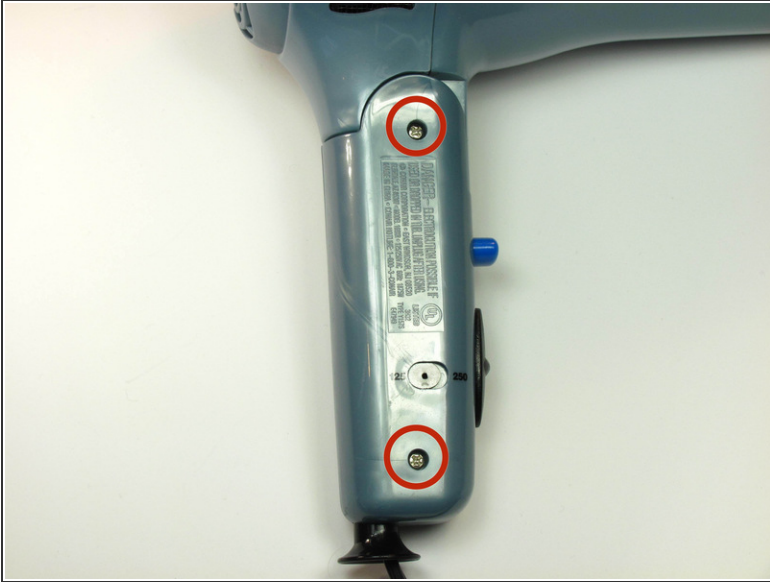
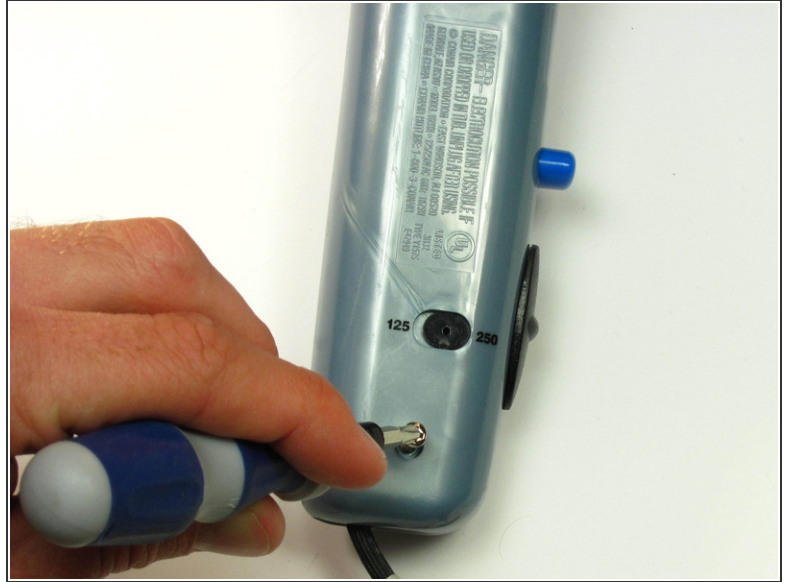
## Step 1 — Handle

- Unscrew the two 18 mm long Phillips #2 screws on the side of the hair dryer.

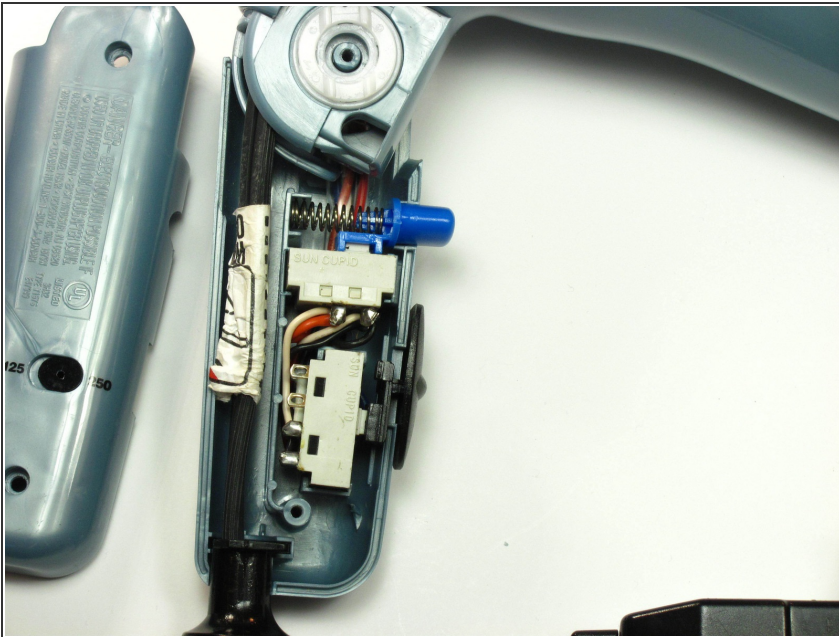
## Step 2

- ⚠ Some pieces may fall out when removing the face of the handle.
- Once you have taken the screws out, take the top half of the handle off by lifting it off of the dryer.

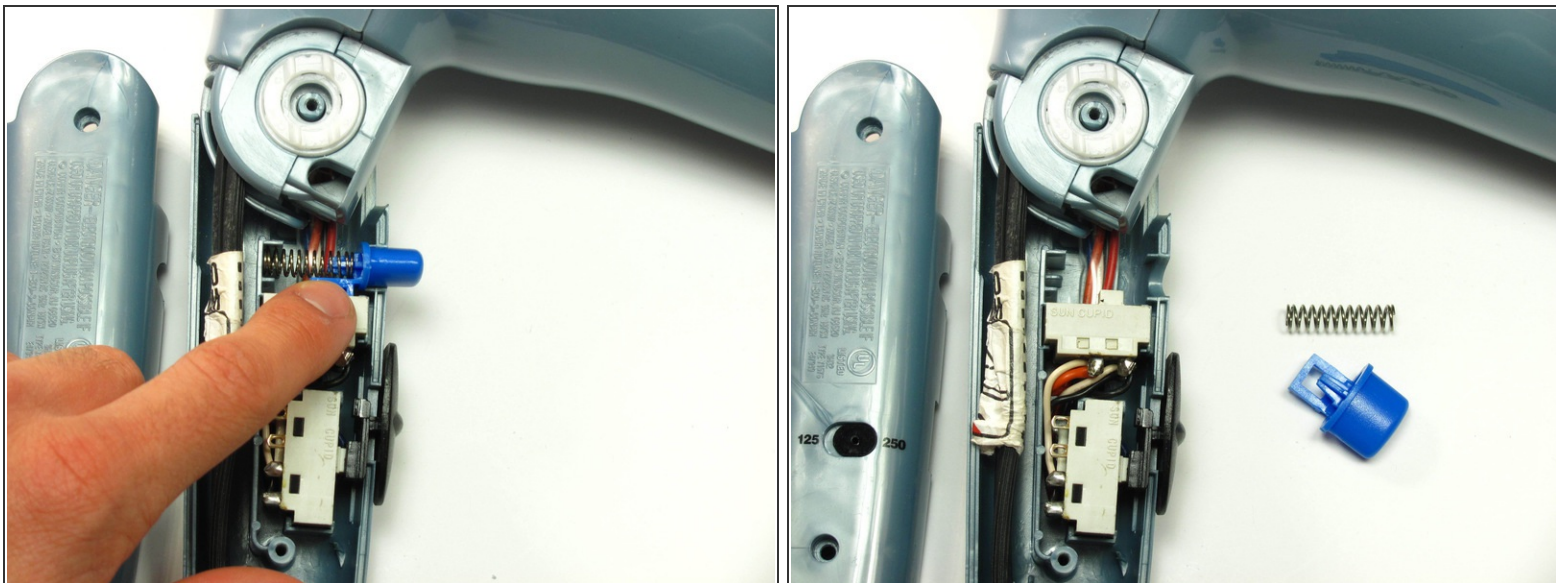
## Step 3 — Cool Down Button

- Take out the cool down button and the spring behind it by gently lifting the button up toward you and pushing it to the right out of its groove.

**i** You may need to replace the button and spring depending on which one is broken.
